nzsee
NEW ZEALAND SOCIETY FOR
EARTHQUAKE ENGINEERING

The seismic performance of structural steel buildings in the 2010/2011 Christchurch earthquake series and the 2016 Kaikoura earthquake: lessons learned, ongoing research and needs of industry

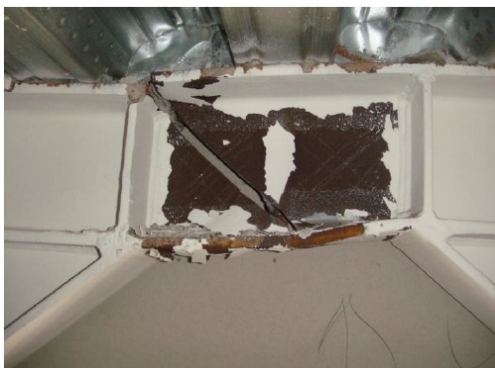
Figure 1. Fractured EBF link in Pacific Residential Building (Clifton, Bruneau, MacRae, Leon, & Fussell, 2011)

The EBF link in level 6 of the Pacific building was fractured, the first time this type of damage was reported globally. This led to the examination of the fractured link. The active link of an EBF is designed to yield

before yielding of the other primary members like bracing, beam or column. In this particular case, no sign of plastic deformation was found on the upper flange and web, rather the link was fractured like a brittle material. The EBF was a K Type arrangement. Careful examination of the fracture showed that the starting point was the shear stud weld. Shear studs were welded on top of beams for embedding concrete slabs to the beams. One of the shear studs were welded on top of the link element at one corner directly above the stiffener of the link beam. Shear stud welding melts a small part of stud material and base steel and fuses them together. Metallurgical and hardness inspections on the weld area indicated that there were slag inclusions and untampered martensite. Also, the location of the shear stud on the corner of the link element was the area that should have been yielded in case of high lateral load. From the visual inspections, it was clear that the fracture started from the weld and spread through upper flange and web to the bottom flange of the link beam, where it got arrested 3 times probably in 3 seismic events. There is a chance that a large crack already pre-existed prior to the first seismic occurrence in September 2010 due to corrosion and concrete on the fracture at the weld area. Scanning fractography indicated that the entire fracture was dominated by a cleavage. From this analysis, it was concluded that the isolated case of the active link failure in level 6 of the pacific tower was due to (1) the particular location of the shear stud at the actual yielding area of the link element (2) the low impact fracture energy of material at surrounding temperature (3) the impact loading due to seismic occurrences. (Ferguson et al., 2013)

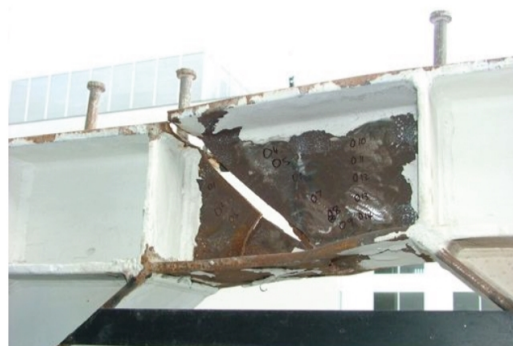
Figure 2. EBF link after removing from its location. (Ferguson et al., 2013)

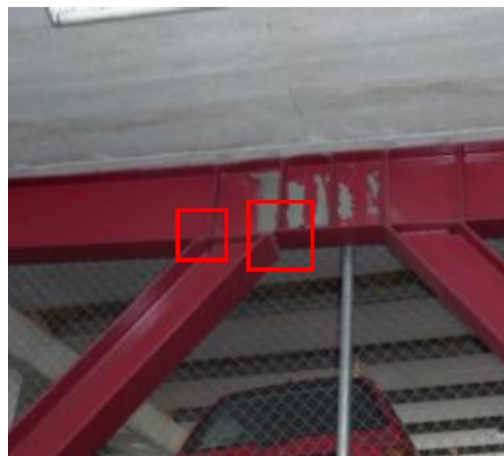
An EBF in a hospital car parking also performed reasonably well. However, fracture in link elements was found in two braced bays. The fractures indicated a ductile overload failure. Closer examination of the damage analysed that the reason for this damage is primarily because the flange of the bracing is not in line with the stiffeners of the link beam and is welded at an offset from the stiffeners (figure 3). This caused severe overload between the junction of beam flange and beam web, resulting in a fracture in the junction and the fracture was spread to the beam web. From this fracture or damage, it can be concluded that the load path through the as-built detail is very crucial. This was a design issue; the joint was fabricated in accordance with the engineer's drawings and shows the importance of getting the load paths correct through these connections

Figure 3. Fracture in EBF Link due to inadequate load-path (Clifton et al., 2011)

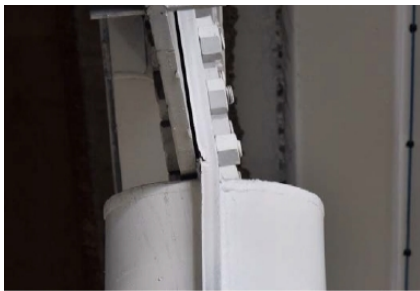
A severe earthquake in Kaikoura in 2016, affected Wellington region. The performance of structural steel was similar to the Christchurch, it exhibited good performance. However, some damage were noticed (HERA, 2017). Wellington had 7 notable multi-level buildings with steel in which 3 were reported with observed damage. One is a three-story building with an EBF system in which the gusset plate connections between the brace and the collector beam buckled out of the plane (figure 4). The collector beam is the beam

in which the active link is located. This buckling showed the gusset plates' vulnerability. This kind of damage was not found in Christchurch buildings as the EBF connections between brace and beam were different, the braces were directly welded under the collector beam. Hence when designing connections, the out of plane actions must be properly accounted for. The second building was an industrial building that had only tension rod bracings. The tensions rods were coupled using a coupler and the damage observed was that, the failure of the bracing rod due to unscrewing of bracing from the coupler (figure 5). Since the structure had sufficient strength the building remained stable even though the tension rod bracings failed. Similar kind of issues was found in Christchurch also, loosening of sag rods. This issue might be prevented by using the lock nuts in couplers in tension rod bracing. The third was a seven storey office building. It is an RC building; the only structural steel component is the coupling beam cast into concrete. This beam works as a dissipator and designed to be the primary yielding element. This acts like the link element in the EBF system. The coupler beam exhibited some yielding and was replaced. Some of the buildings were retrofitted with seismic load resisting systems, like McKenzie building was reinforced by retrofitting Eccentrically braced frame in 2010 which could be one of the reasons for its good performance as these reinforcements would have helped to resist seismic forces.

Figure 4. Gusset plate buckled out of plane in bracing. (HERA, 2017)

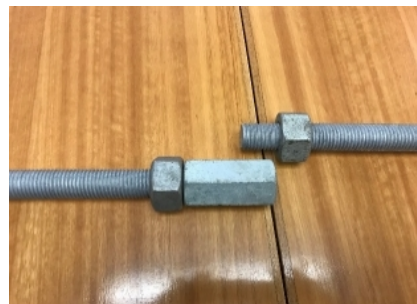
Figure 5. Bracing rods unscrewed from coupler (HERA, 2017)

From various literature reviews, it was found that the damage resisting systems performed well as they were designed to do in both the earthquakes (Christchurch and Kaikoura). Some structural damage was found post-Christchurch earthquakes, which were not expected to occur, like active link fracture in the EBF system, weld fracture in a CBF system. Investigation of this damage led to the conclusions that these were primarily because of the construction issues, inadequate as-construction load path, and improper weld designing and not according to the capacity design principles respectively. Some structural steel damage was found after the Kaikoura earthquake also, these were out of plane buckling of gusset connection between brace and collector beam in the EBF system, the tension only brace rods unscrewed from the coupler. Investigation conclusions led to better design on gusset connections taking into consideration the out of plane buckling and use of lock nuts on tension rod brace and couplers.
