Repair and Reinstatement of Douglas-fir CLT Hold-down Connections using Mixed Angle Self Tapping Screws

T.D.W. Wright, M. Li, M Gedyma, & H. Lim

University of Canterbury, Christchurch.

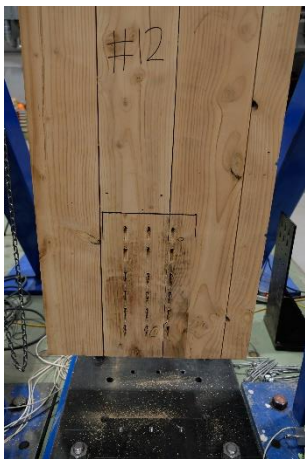
Properly designed and installed mixed angle screw connections cause very localised damage to the timber panel. This localised damage leaves the integrity of the timber panel itself intact, with the damaged screws able to be withdrawn and removed. It is also recognised that timber connections utilising external steel side plates have a key advantage in that fasteners inserted from the outside can be easily removed post-earthquake. Inclined screws experience local withdrawal failures with shearing of wood fibres around their threads. 90 degree screws experience local crushing or embedment failure around the screw shank. Based on the localised damage observed, a two-step repair and reinstatement process was employed.

A – Damage post original test

The first step is to repair the damage to timber caused by the withdrawal of inclined screws, and the lateral deformation of the 90 degree screws. This is shown in Figure 2. First the holes are cleaned of loose timber

fibres. For the inclined screw holes, this is done by reaming the hole with a drill bit sized to suit an epoxy injection tube. For the 90 degree screw holes, the loose timber on the edges of the hole is removed by hand with a chisel and pliers, or by using a handheld router to trim the edges of the hole. These holes are then blown out with compressed air to remove any remaining timber fibres or dust. Epoxy is then injected into the holes making sure that the epoxy can penetrate and fill the entire hole. In this study Hilti HIT RE-500 was used, with an extension tube being used to inject epoxy into the base of the hole similar to conventional use in concrete construction. Excess epoxy was cleaned off, and once cured the area sanded to remove any remaining excess epoxy from the timber surface.

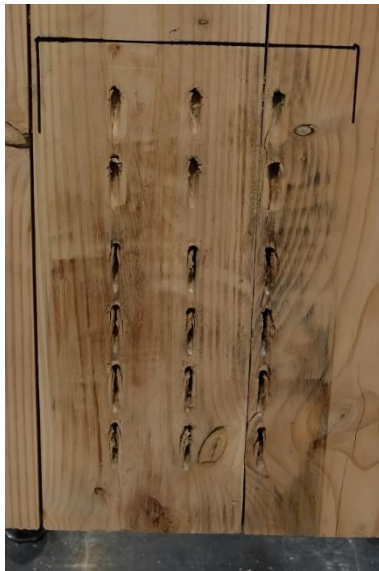
As previously discussed, mixed angle screw connections may have highly localised damage when detailed correctly. In all the tests presented in this paper, partially threaded screws were used to encourage a ductile withdrawal failure in the timber, rather than a brittle steel tensile failure in the screw. In all original tests, the failure mode observed for the inclined fasteners was screw withdrawal. In Test Set 1 using 10 mm 90 degree screws some screw head failures were observed in the 90 degree screws, but it was found that there was a strong correlation between incidents of over-torquing during installation and head failure on these 10 mm washer head screws. In Test Set 2, all 90 degree screws failed due to bearing in the timber.

No significant changes in the damage to timber were observed between original and repaired tests, as illustrated by the original and repaired Specimen 1.2 in Figure 5. In both original and repaired tests there were instances where cracks formed along a row of fasteners, but this row shear was restrained by the internal CLT cross-layers. There was no evidence to suggest any differences in failure mode due to epoxy repair, although it should be noted that in some cases epoxy was hit when installing the screws. As previously discussed this may result in an increase in withdrawal strength, but due to the partially threaded inclined and 90 degree screws, this increase in screw strength did not result in screw tensile failure.

a - Original

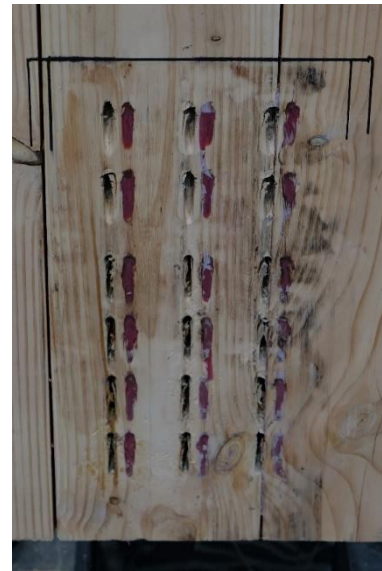
b - Repaired
