Seismic Performance of Precast Hollow-core Units Seated Within the Plastic Hinge Region

M. Mostafa, F. Bölker, L. Hogan & K. Elwood

The University of Auckland, Auckland, New Zealand.

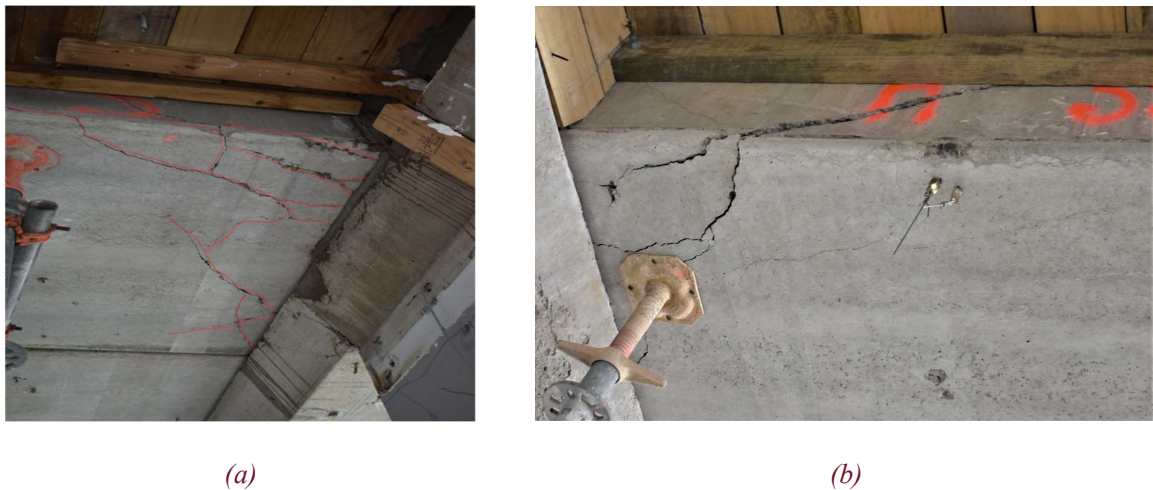
Observations from an instrumented building with hollow-core floors following the 2016 Kaikōura earthquake showed unexpectedly poor performance of beta units. The beta units in the building discussed herein can be classified as un-notched units, and the centreline of the units was either within the column width or the plastic hinge region. The floor-to-support connection detailing used in the building investigated incorporated the detailing requirements of the current design standard, NZS3101:2006-A3. However, beta units were observed to incur more damage than units seated away from the plastic hinge regions and severe damage to beta units due to other mechanisms was observed (Figure 4).

Figure 4: Examples of beta units damage observed a) previously unidentified damage pattern b) transverse cracking at the unit soffit accompanied by longitudinal cracking

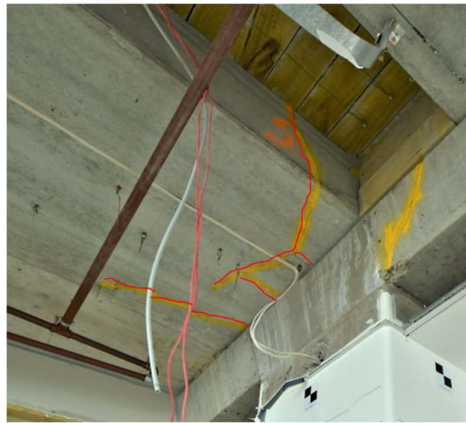
To quantify the extent of damage sustained in the floors, a qualitative framework was developed to classify different observed damage states. The inspection of the floor units was only possible from the soffit. Hence the categorisations of the damage sustained in the hollow-core units primarily relied on the inspection of the floor unit's soffit. Each unit end was assigned a damage state from light-severe based upon how likely the gravity load path was compromised. A light damage state represented negligible or cosmetic damage, and a severe damage indicated that the unit would likely collapse when subjected to design gravity loads. The damage severity for each end of the hollow-core units was plotted against each unit location relative to the nearest column for 684 unit-ends (i.e. 342 units), as shown in Figure 6. It was noted that there was a trend for the damage severity, where the closer the unit was to a column, the higher the degree of damage. Furthermore, beta units were observed to sustain transverse cracking at the unit soffit accompanied by web cracking (Figure 5) at storey drift demands as low as 0.6% in the longitudinal direction of the unit and 1.0% in the transverse direction. More severe beta units damage was sustained at higher drift demands. Preliminary analysis suggests that diaphragm demands exacerbate the damage to beta units due to the tendency of collector forces to concentrate at column locations. These inertial loads increase up the height of the building due to higher floor accelerations may have influenced the occurrence of beta unit damage at the low drift demands experienced by the upper floors of the case study building (Mostafa et al., 2022).

Figure 5: Damage sustained in hollow-core unit under low drift levels

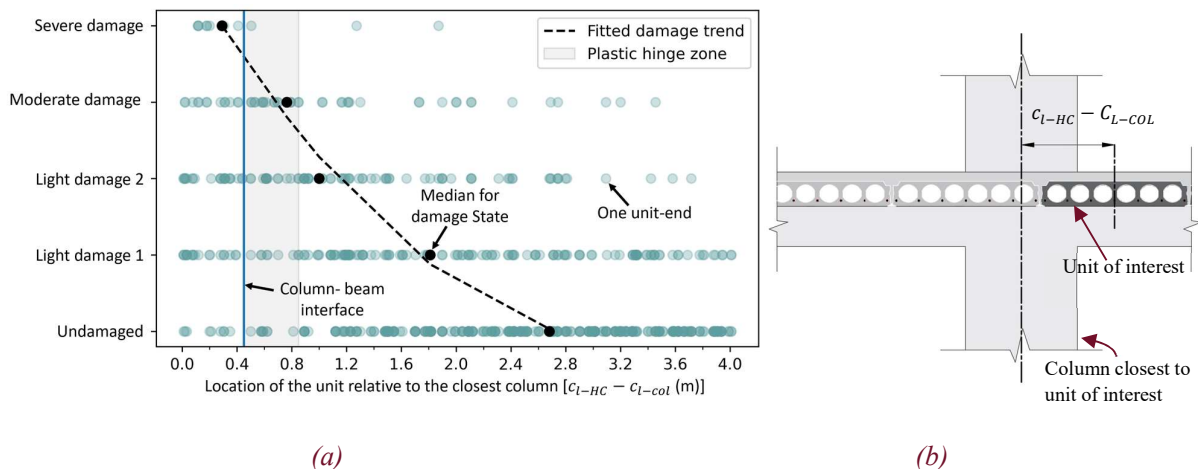
Figure 6: a) damage trend observed in the case study building showing the closer a unit is to the column the higher degree of damage b) schematic showing location definition for units used in the damage trend plot

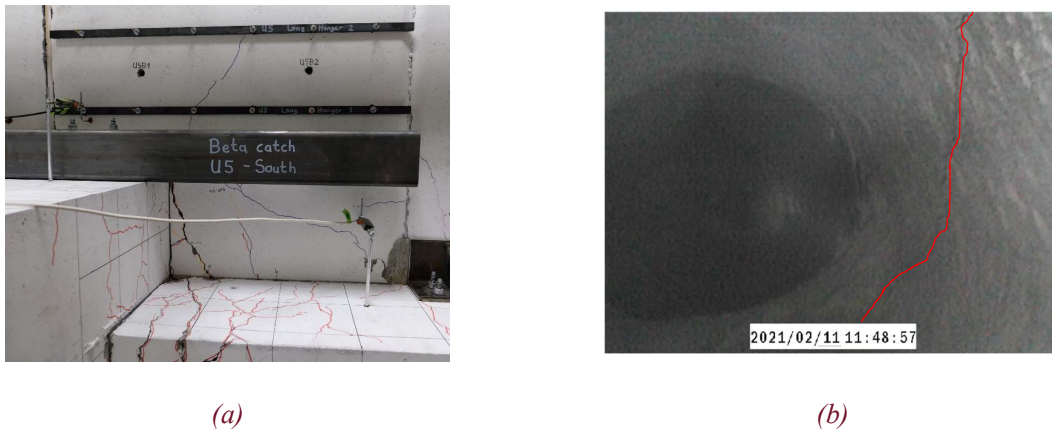
As the experiments progressed, local deformation induced into the beta units caused external floor damage in the form of transverse, diagonal and longitudinal cracking in the vicinity of the notches (Figure 9a). This region of high discontinuity in the beta units appeared to be more prone to damage compared to the support region of hollow-core units that are seated away from the plastic hinges.

Moreover, the onset and extent of internal cracking of the unreinforced webs in beta units was more substantial compared to other units seated away from the plastic hinges, but not as severe as in alpha units. An example of a web-crack in the direction of gravity shear in a beta unit is shown in Figure 9b.

Figure 9: Examples of beta unit damage showing (a) soffit cracking in beta unit at 2.5% in Test 1 and (b) web-crack in beta unit at 1.0% drift in Test 2 as seen from unit void (highlighted in red)

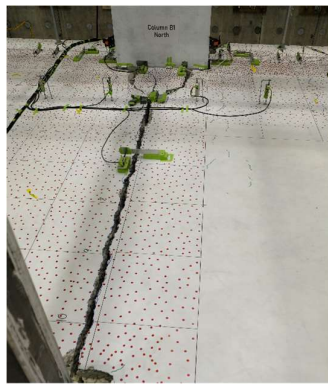
The two super-assembly experiments also furthered the understanding of how elongation from plastic hinges at intermediate columns can impact the floor diaphragm of a typical existing hollow-core floors. In the first test, the elongation of the plastic hinges at the intermediate columns generated a full-length longitudinal split between the beta units as shown in Figure 10a. Once the non-ductile 665 HRC mesh across the split ruptured, all the deformations concentrated in this single crack, resulting in a complete separation of the floor diaphragm. While inertial forces were not simulated in the super-assembly tests, such beta unit damage is expected impact the diaphragm load paths significantly.

In terms of beta unit performance, the longitudinal split reduces the demands induced into the beta units themselves due to transverse deformations. This is because the split relieves the restraint from the neighbouring beta unit. On the contrary, the split also removed any gravity load sharing between the already heavily damaged beta units.

Figure 10: Longitudinal splitting from elongation of plastic hinges at intermediate columns forming (a) between the beta units and (b) beyond the stitching bars within the beta unit (highlighted in green).

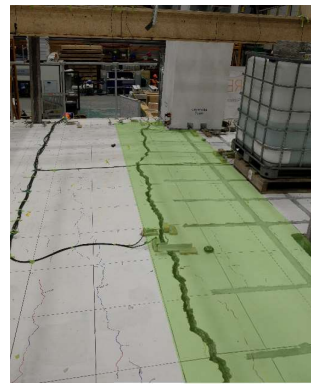
(b)

It is worth noting that, in the second test, the column ties were post-installed with additional transverse stitching bars to replace the load path across the cut mesh. The presence of the ductile stitching bars did hinder the crack to form between the beta units but caused the longitudinal split to form beyond these bars through the beta unit itself, as shown in Figure 10b.
