Monitoring technologies to manage landslide risk to transportation routes in the Lower North Island

D L Stewart

WSP, Wellington

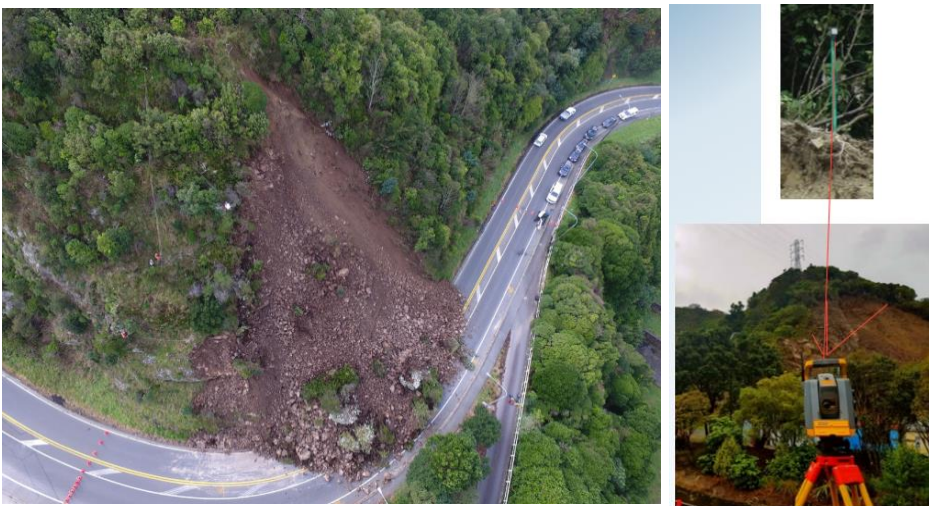
Figure 1: Ngaio Gorge Road, July 2017 rockslide and EDM target monitoring setup during earthworks

A large (~1500m³) rockslide occurred on a 1970s rock cutting in late July 2017 after a period of heavy rain (Figure 1). A 1974 precedent for this type of failure was discovered retrospectively at the site however not of this magnitude. Due to the unprecedented scale of this failure, the 2016 earthquake may well have weakened the slope providing the conditions for a larger than normal failure to occur.

In order to manage rockfall risks to workers removing the debris (in order to reopen the road), a network of reflective targets was strategically placed around the perimeter of the slip by abseilers. These targets were monitored by a manned real-time EDM instrument (Figure 1). Accelerating movement was detected on one target during earthworks, enabling sufficient warning to the excavator operator working under the scarp to move out of way prior to a large secondary failure.

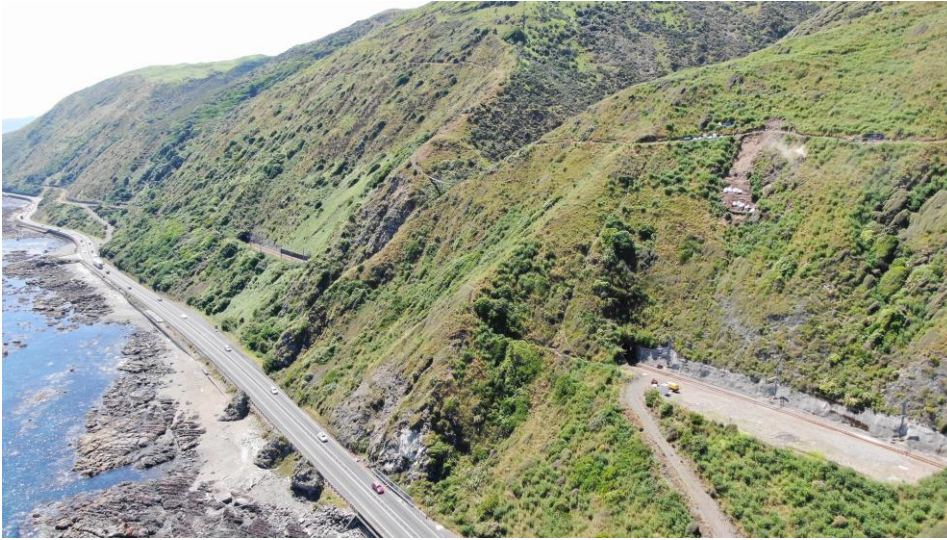
Figure 3: Paekakariki Escarpment – with multiple slope hazards affecting road, rail and the Te Araroa (TA) trail. Works to mitigate NIMT 33.44 slip site visible at upper right

The steep slopes along this coastal section north of Wellington present ongoing risks to road, rail and the popular Paekakariki Escarpment walking track (Figure 3). While seismic risks have precipitated the construction of the Transmission Gully highway to manage the risk to road access to Wellington, the risks to the North Island Main Trunk (NIMT) line and walking track remain. Storm events in 2020 and 2021 have resulted in slips that pose heightened risks. Monitoring has played a key role in assisting risk management of the NIMT.

Following a slip in late 2020 upslope of the line at NIMT33.44, two catch fences were constructed beneath the main slip area below the TA track (Figure 3). These were instrumented with tilt sensors, draw wire extensometers and cameras, and a digital rain gauge and camera were installed at rail level. During a heavy rainfall event in August 2021, significant tilting of the upper fence was identified (Figures 4 and 5) resulting in an increased likelihood of an event that could affect the rail below. Without tilt sensors this movement would have gone undetected, until inspections many days later. Cameras taking photos along the fence every 30 minutes allowed retrospective viewing of the failure in (slow) motion and allowed the full width of moving slope to be identified. While the slope did not fail catastrophically the movement indicated the slope at that location and time had a factor of safety below 1.0. During heavy rain in early December 2021 tension cracks developed on the slope above the walking track. A tilt sensor was relocated to this marginally stable slope to help manage risk to contractors stabilising the slope below. A heavy rain event in mid December 2021 resulted in further movement of this slope and sensor (Figure 4) which was directly correlated with the rainfall.

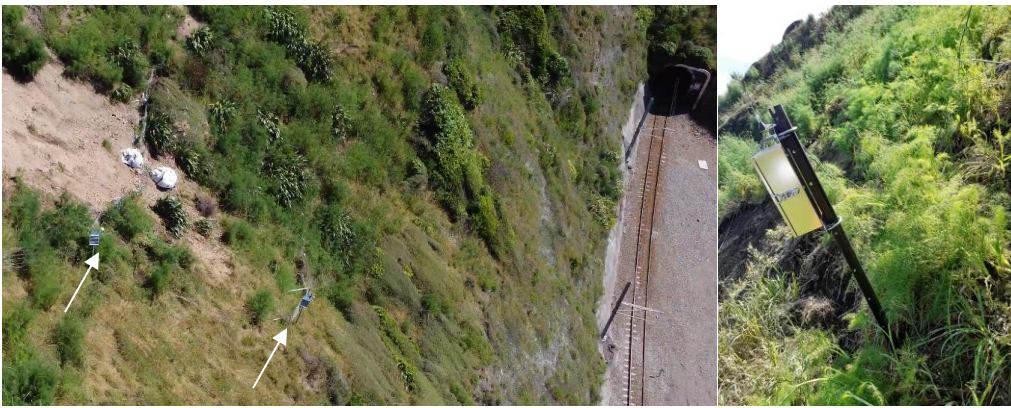
Figure 4: Monitored catch fences (arrowed) at NIMT 33.44; tilted sensor at right after movement

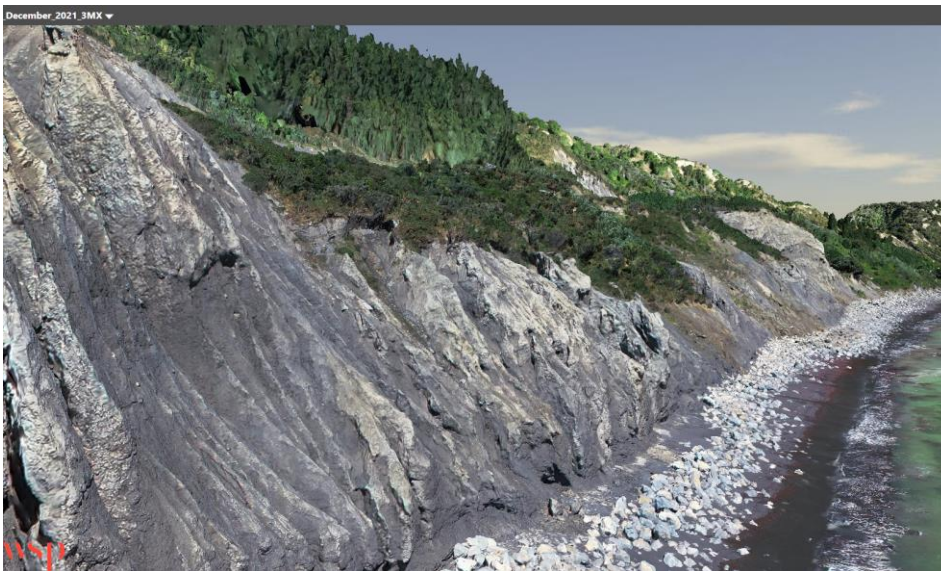
Figure 7: Lower section of Johnsons Hill landslide on Cape Palliser Road, UAV 3D model snip, with coastal erosion acting as a key contributor to slope instability. Model allows viewing of difficult-to-reach features.

Coastal roads in hilly terrain face multiple threats from climatic, coastal and seismic events. The Johnsons Hill landslide (Figure 7) affects a ~200m long section of Cape Palliser Road and periodically moves, with reactivation noted following the 2016 Kaikoura Earthquake. Given the increasing risk to the landslide from sea level rise, South Wairarapa District Council are undertaking investigation of the landslide and monitoring including slope change detection from repeat UAV models as well as set up of a monitoring system. This will enable movement trends to be identified to allow targeted risk mitigation measures to be implemented to maximise the security of the road. Using UAV 3D models and existing regional LiDAR data (Figure 8), the geomorphic expression of the landslide features was able to be mapped, despite being obscured by vegetation. The use of these 3D models allows rapid inspection and visualisation of the landslide features that would not otherwise be able to be easily identified, and assists optimising of locations for monitoring points, on the surface or in boreholes.
