Repair and Reinstatement of Douglas-fir CLT Hold-down Connections using Mixed Angle Self Tapping Screws

T.D.W. Wright, M. Li, M Gedyma, & H. Lim

University of Canterbury, Christchurch.

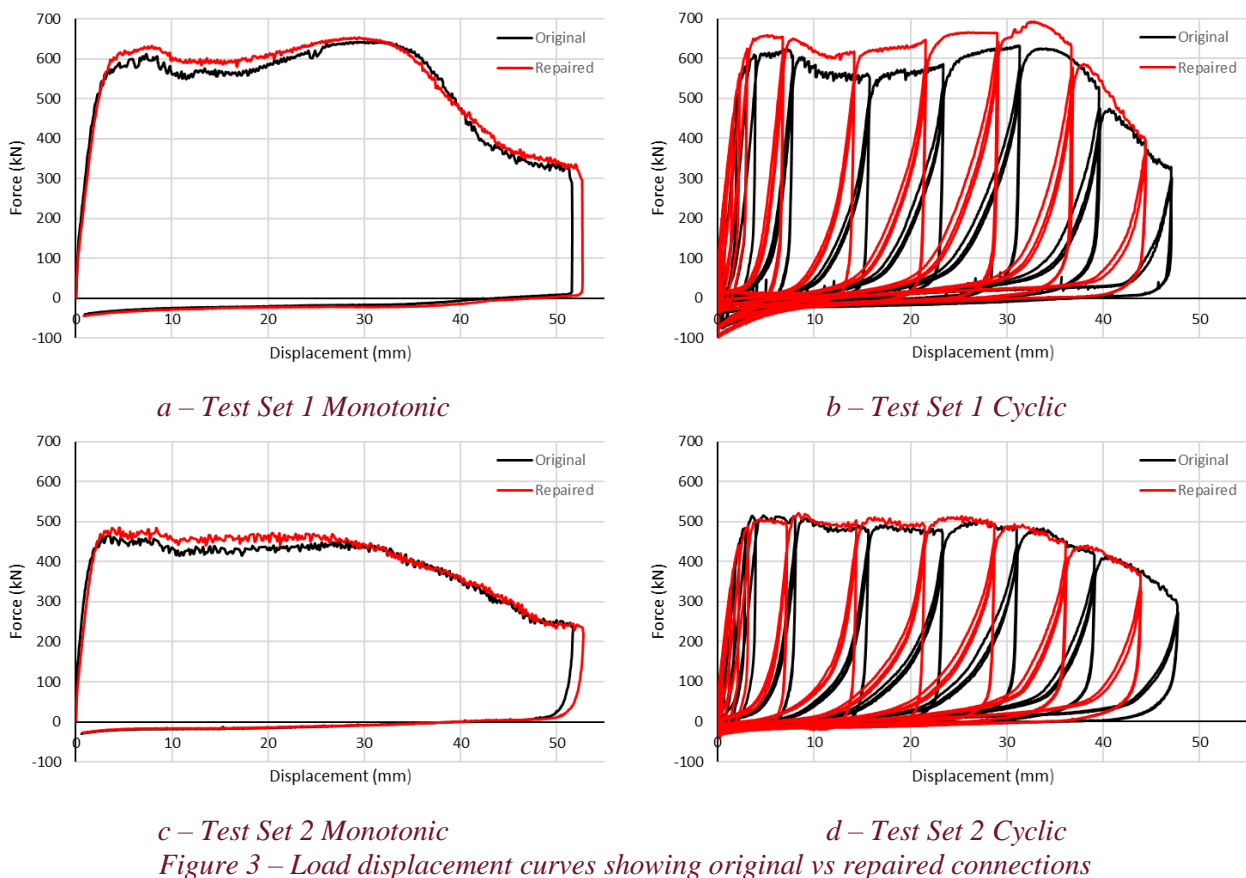
From Figure 3a and b, it can be seen that Test Set 1 using 12 inclined fasteners and 24 10 mm diameter 90 degree fasteners has greater ultimate and yield strengths than Test Set 2. Test set 1 reaches a clear initial peak at a displacement of approximately 5 mm, where the inclined screws reach their maximum capacity, followed by a drop as the inclined screws withdraw from the timber. The second peak at a displacement of approximately 30 mm corresponds to the 90 degree screws reaching their maximum capacity.

Test Set 2 reaches an initial peak at approximately 5 mm displacement as shown in Figure 3c and d, but in contrast to Test Set 1 has no second peak at approximately 30 mm due to the reduced number of 90 degree screws decreasing the load carrying capacity at high displacements. Covered in more detail by Wright (Wright et al., 2021), this shows how inclined to 90 degree screw ratio can be used to adjust the performance of the overall connection.

This increase in strength could be due to two factors: 1) some of the inclined fasteners may hit layers of epoxy on installation. This would lead to an increase in withdrawal strength in the inclined fasteners, and be evident on the initial peak seen in Figure 3; and 2) the epoxy may provide a local reinforcement of the timber and increase the bearing strength of the nearby 90 degree fasteners. This would lead to an increase in shear strength of the 90 degree fasteners and would be seen as a slight increase across the full displacement range, partially apparent where the 90 degree screws hit their max capacity at approximately 30 mm displacement.

Based on the curves presented in Figure 3, it was most likely that the increase was due to inclined fasteners hitting epoxy as the greatest increase in strength is at the initial peak.

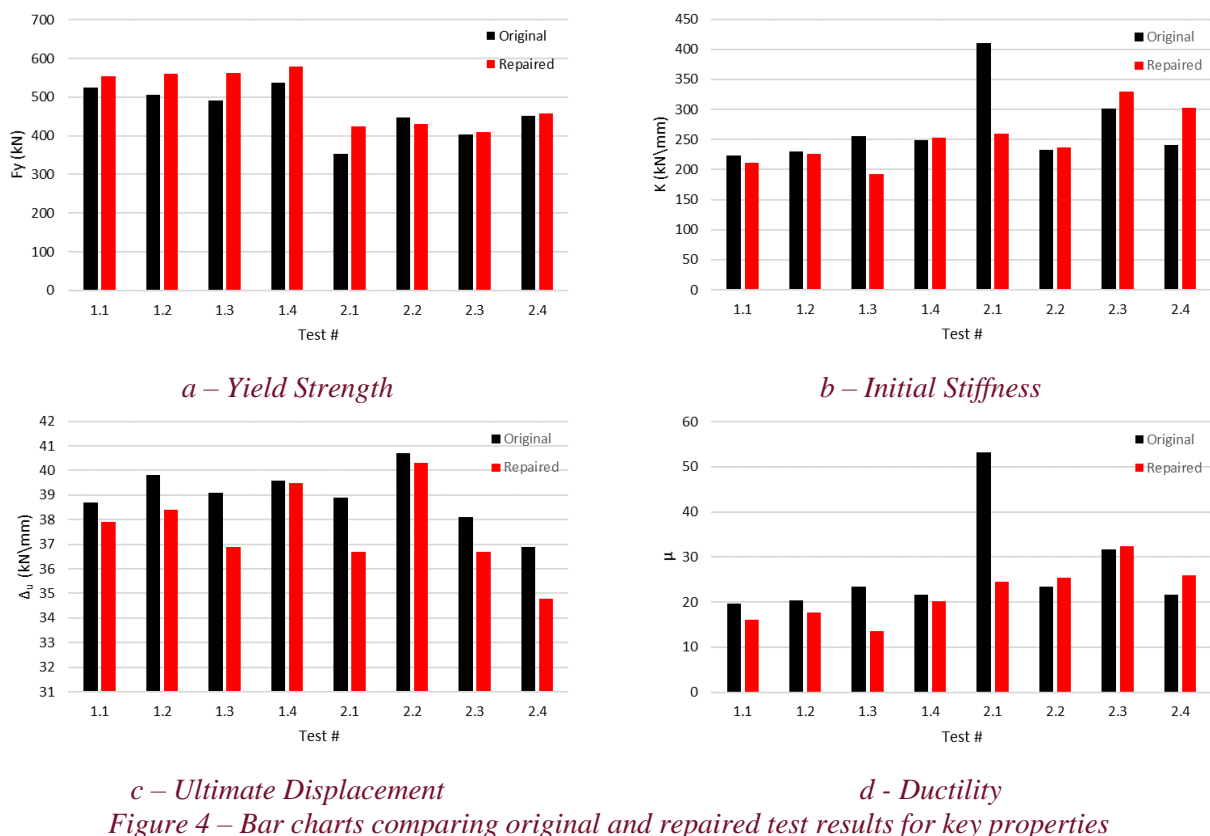
Figure 4 – Bar charts comparing original and repaired test results for key properties

A comparison of yield strength between original and repaired tests is shown in Figure 4a. It can be seen that yield strength has increased slightly among all repaired tests. This is confirmed through a statistical

hypothesis t-test where it is found yield strength of the repaired tests is greater than the original test at a 5% level of significance. Therefore, there is a statistically significant increase in yield strength after the repair.

It should be noted that any increase in strength post-repair could have overstrength related implications for capacity design,

although the ability to use probable strengths in assessment may mitigate this issue.

Displacement capacity or ultimate displacement is shown in Figure 4c, and ductility results are shown in Figure 4d. In most tests repaired displacement capacity was still quite high, although slightly lower than the original ones. From Figure 3, it can be seen that the performance of the original or repaired curves is very similar. In this study, ultimate displacement is defined as the displacement where the load drops to 80% of the peak. Due to the slight increase in strength discussed previously, this definition of ultimate displacement is causing the repaired ultimate displacement values reported to be slightly smaller than the original even though the performance of the repaired test was very similar to the original test. Comparing the load displacement curves of all original and repaired tests, there is no significant change in performance at large displacements. Similarly, ductility is highly dependent on the yield point of the connection. In stiff but highly ductile connections such as mixed angle screws, small changes in yield displacement can result in large changes in ductility. When considering the previous discussion about variability in stiffness, the differences in ductility observed should be considered with caution.
