Seismic Performance of Precast Hollow-core Units Seated Within the Plastic Hinge Region

M. Mostafa, F. Bölker, L. Hogan & K. Elwood

The University of Auckland, Auckland, New Zealand.

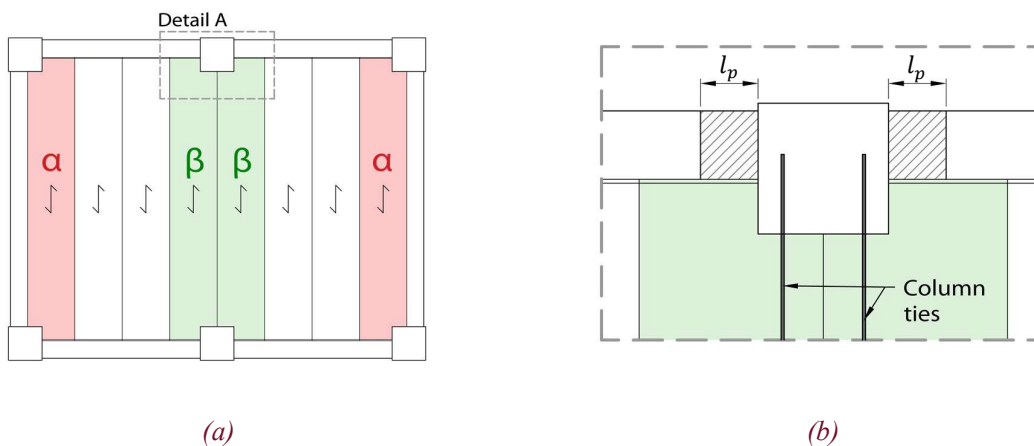
Figure 8 - Super-assembly specimen showing (a) top view of the beta unit seating arrangement and (b) Detail A of beta unit support

The connection detailing and layout of the tested single span hollow-core floor is representative of existing 1980s buildings in Wellington (Figure 8a). The specimen comprised two beta units with notches to fit the units around the precast columns as shown in Figure 8b.

While those two beta units were not seated on the column directly, a connection through the column ties that extended from the middle columns into the topping layer existed.

As the experiments progressed, local deformation induced into the beta units caused external floor damage in the form of transverse, diagonal and longitudinal cracking in the vicinity of the notches (Figure 9a). This region of high discontinuity in the beta units appeared to be more prone to damage compared to the support region of hollow-core units that are seated away from the plastic hinges.
