A quantitative risk assessment of seismic slope stability for a tailings dam

V.Y. Chen, Y. Wang, E. Torvelainen & T. Matuschka

Engineering Geology Ltd, Auckland, New Zealand.

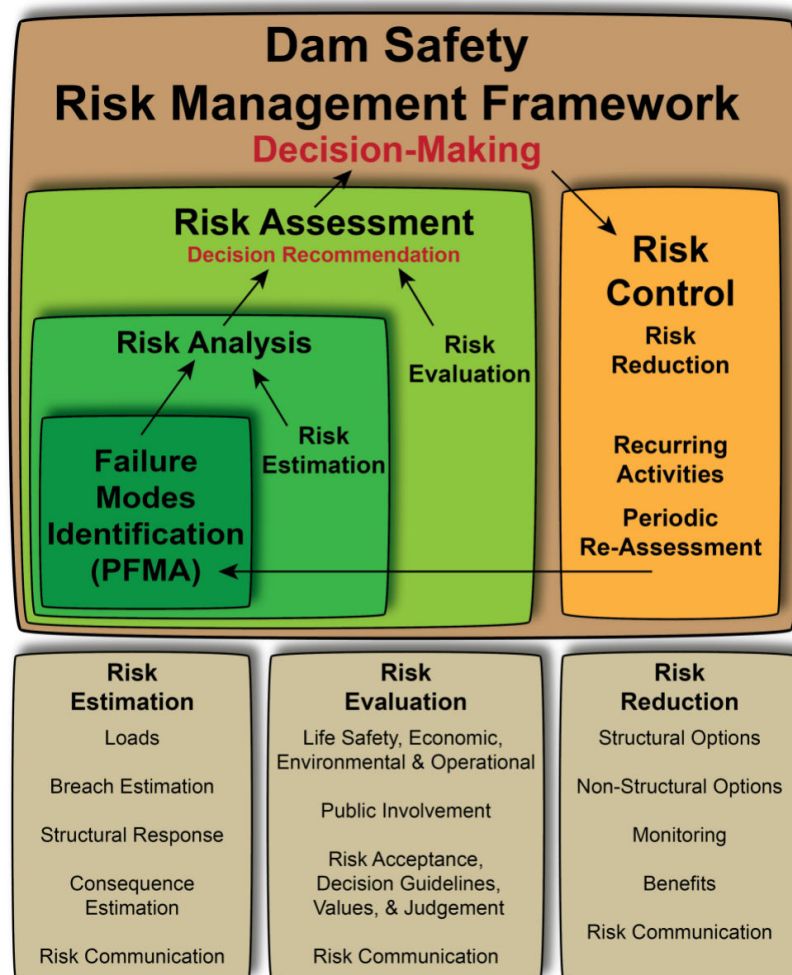
Figure 2: Dam safety risk management framework (adopted from FEMA, 2015)

Figure 2 shows how risk analysis, risk assessment, and risk management relate to each other. For risk analysis, the key activities are failure mode identification and risk estimation (assessing loading on the dam, structural response, consequences of breach, etc.). Risk assessment takes the outcomes from the risk analysis and evaluate the risks (i.e., probabilities of consequences). Decision making recommendations to reduce the risks can then be made through the insight gained from the risk assessment. Ultimately risk management is about decision making to manage the risk. For dams with high risks this is primarily about risk reduction. Risk communication, although not specifically identified in Figure 2, is a critical part of each component of risk management (FEMA, 2015). Risk may change throughout the lifecycle of a tailings dam and is re-assessed periodically or when there are material changes that may affect risk.

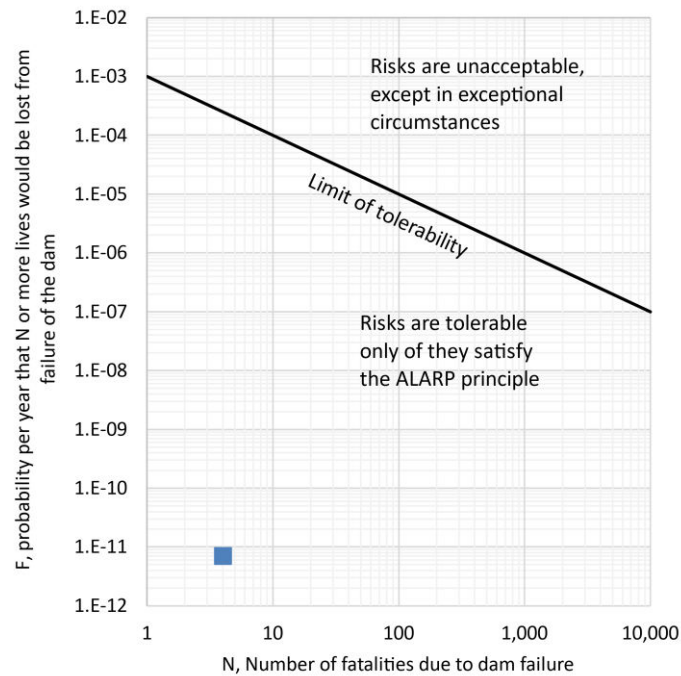
Figure 3: Assessment against the limit of tolerability defined in ANCOLD Guidelines.

The societal risk criteria for existing dams defined in ANCOLD guidelines is shown in Figure 3. The annual probability of catastrophic failure due to seismic induced slope instability estimated from the event tree analysis is $7.04\text{E-}12$. It is the sum of the probability of the following four pathways in the event tree, and plots well below the limit of tolerability.
