# Turnbull Library: Strengthening for Heritage and Resilience

*N.K. Vance, R.M.L. Inch & R.H. Ballagh*

Dunning Thornton, Wellington, New Zealand.

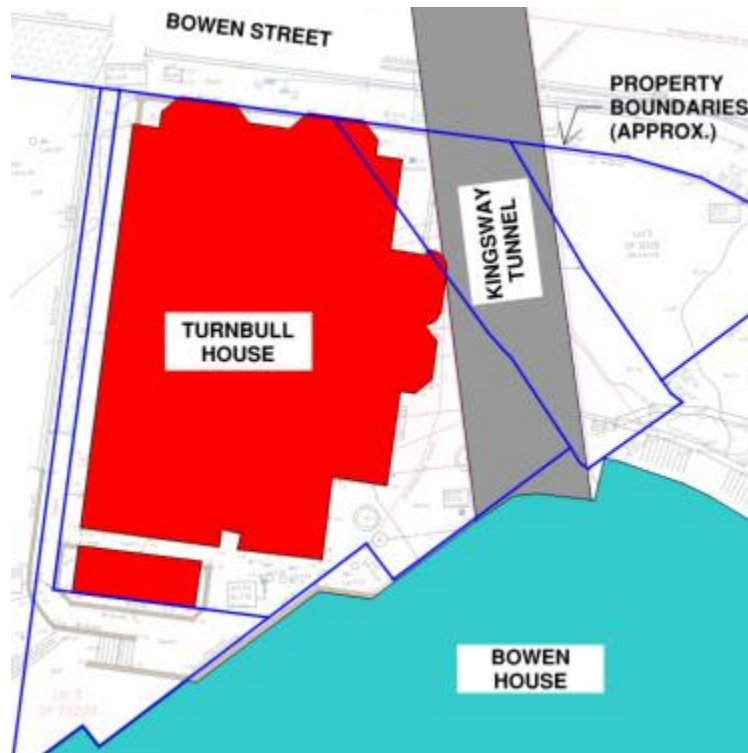
*Figure 1.5 – Block Diagram Showing Adjoining Structures and Approximate Boundaries*

To the east, the Kingsway Tunnel passes below the entrance portico. This tunnel connects Bowen House with the parliamentary buildings across Bowen Street. To the south, the main building has a separation of approximately 900 millimetres to an existing boiler house (southwest corner) and the boundary to Bowen House (southeast corner). These constrain the space available for implementing an isolation retrofit.

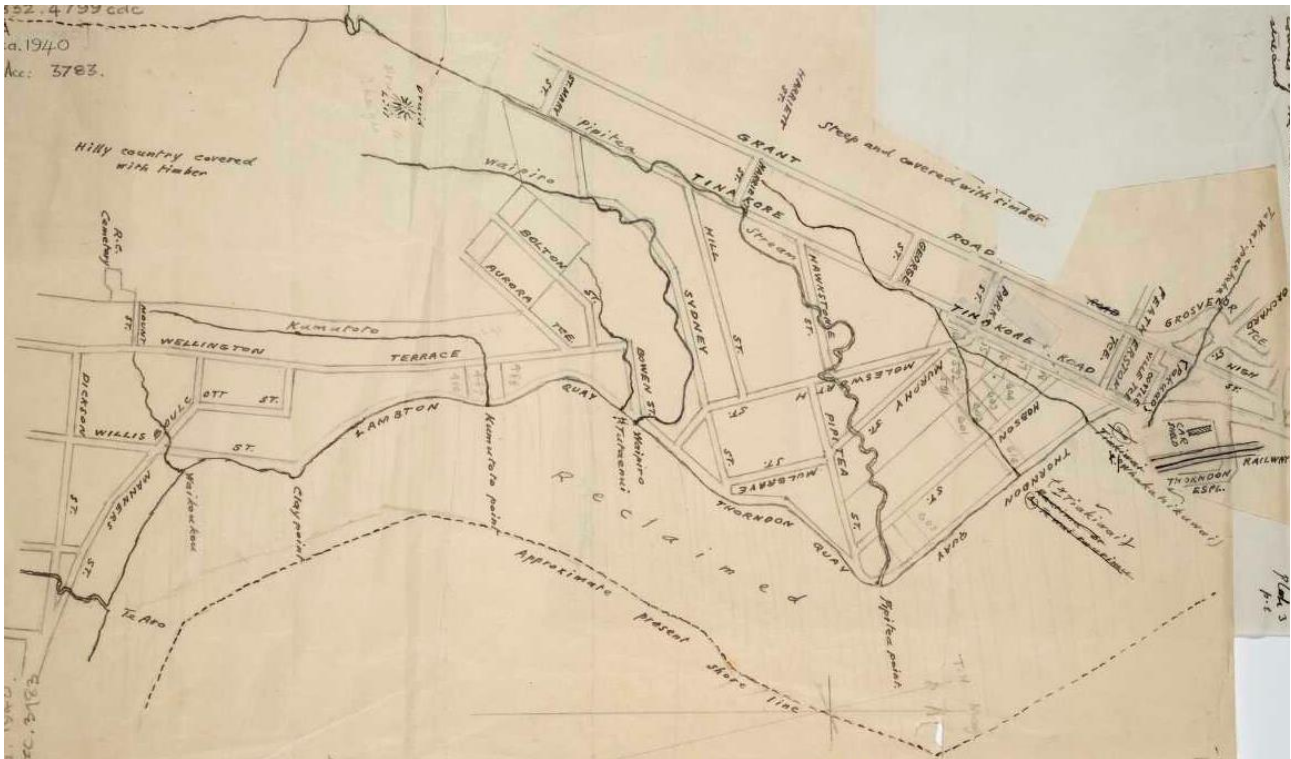
Figure 1.6: Historic Map of Wellington Showing Historic Rivers (National Library Collection access via <https://natlib.govt.nz/records/22612149>).

Factual and interpretive geotechnical reports have been completed by BECA. These determined that the site consists of loose/soft fill over alluvial materials. The building is likely sited over the former Tutaenui Stream, which carried water from Te Ahumairangi to the harbour. The soils around the historic stream are softer and historic settlement has been observed in the middle of the western façade.

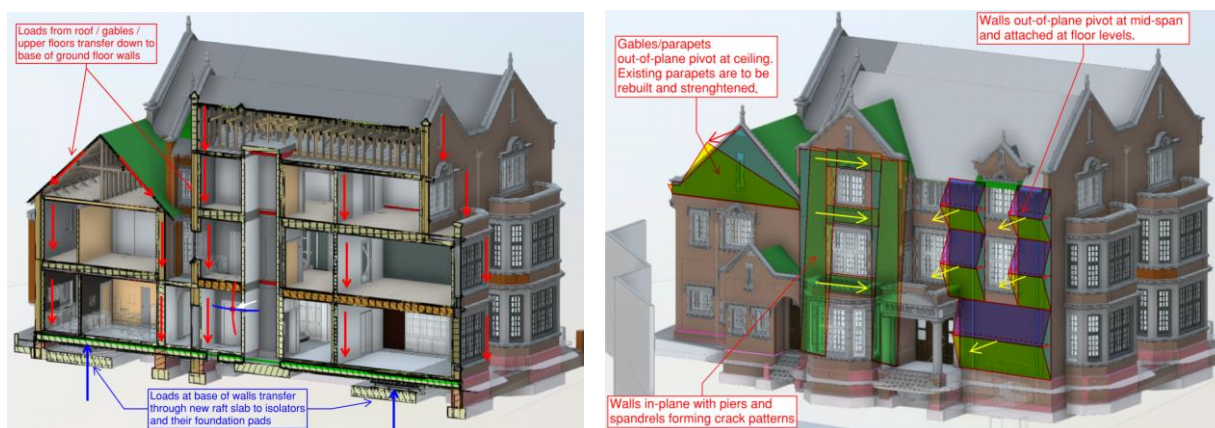
Figure 3.1: Overview of the Existing Structure and URM Walls.

The first step was to determine the capacity of the existing structure and the associated load demands. The building mass and weight at each level was determined. A load take-down for each wall line provided axial loads for determining the URM wall in-plane and out-of-plane capacities, and the inputs for the new raft slab design. The URM wall capacities were assessed using 2017 Assessment Guidelines C8. The acceleration capacities of the URM walls in and out-of-plane provided a target base isolation acceleration at which the URM walls required no strengthening. These accelerations were used to formulate a preferred isolator, then were provided to EPS (isolator supplier) to inform the triple pendulum design and selection.

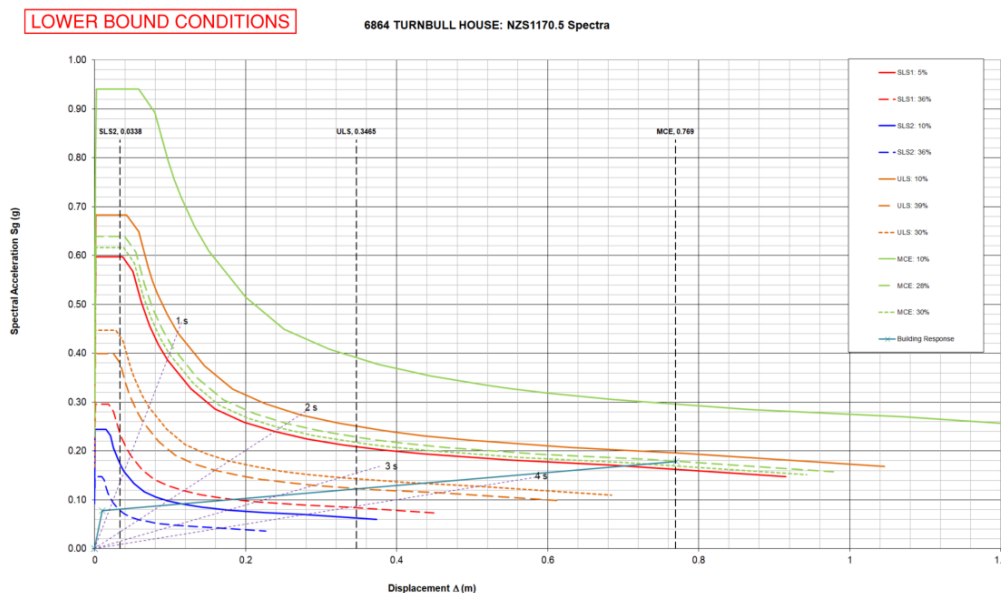
Figure 3.3: Isolator displacements for DTC isolator design to NZS1170.5 design spectra.

Chapter 17 of ASCE/SEI 7-22 “equivalent lateral force procedure” was used to determine the initial parameters of the triple pendulums. Pendulum radii ( $R_i$ ), heights ( $h_i$ ) and surface frictions ( $\mu$ ) were assumed, and a displacement estimated. The initial estimated displacement was iterated until the isolation acceleration and the spectral acceleration ( $C(T)$ ) from NZS1170.5 converged. The effective damping, period and acceleration of the isolation system were also calculated for each displacement. This final converged displacement ( $D_m$ ) provided the expected COM displacement for the isolation system. Lower and upper bound displacements were determined based on different isolator surface frictions ( $\mu$  values) for CALS, ULS and SLS load cases. The ULS case was taken as 70%NBS and the CALS case was taken as 1.5xULS as per the draft Seismic Isolation Guidelines. The final system displacements and damping ratios were plotted against the NZS1170.5 design spectra.

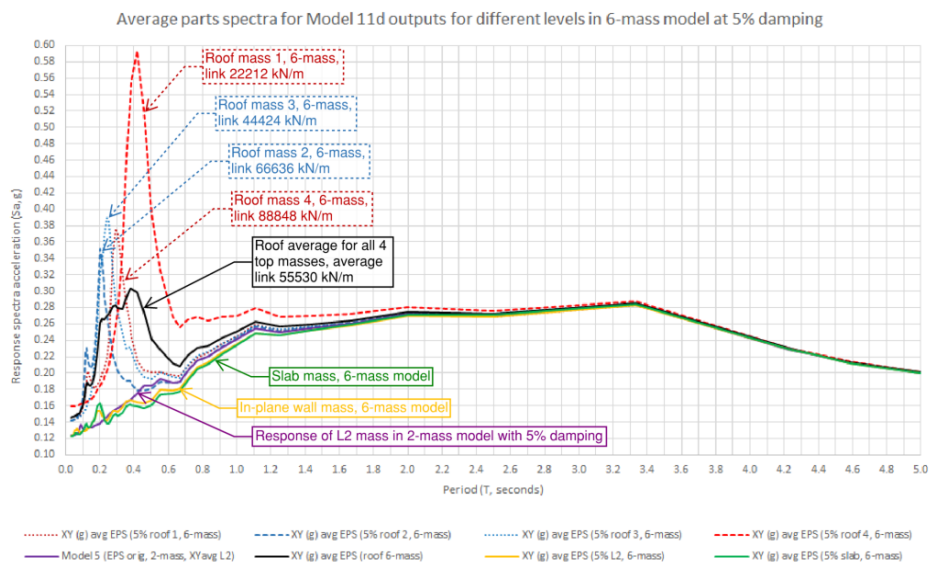
Figure 3.5: Parts spectra response for each mass in the 6-mass ETABS model to compare stiffness effects on accelerations and single level isolation model (green line).

It should be noted how well isolated the building is, with a very flat floor spectra.

Further splitting the OOP masses with varied link stiffnesses, reduced the acceleration drag effects of the upper masses on the slab mass response. The average parts accelerations for each mass were plotted to compare responses. Figure 3.5 gives an example output for the 6-mass ETABS model at 5% damping. The

slab mass (green) follows the isolator behaviour whilst the upper OOP masses have higher acceleration peaks depending on their mass and stiffness, ranging from 0.35g to 0.59g. Figure 3.6 shows the mass responses from the different models used to derive a parts spectra.
